USA SERVICE OPERATIONS TECHNICAL SERVICES DEPARTMENT SERVICE BULLETIN

SB06175

SUBJECT: TESTS TO RUN BEFORE INSERTING BATTERY
UNITS: ALL FLEXVOLT
DATE CODES AFFECTED: ALL 54 VOLT

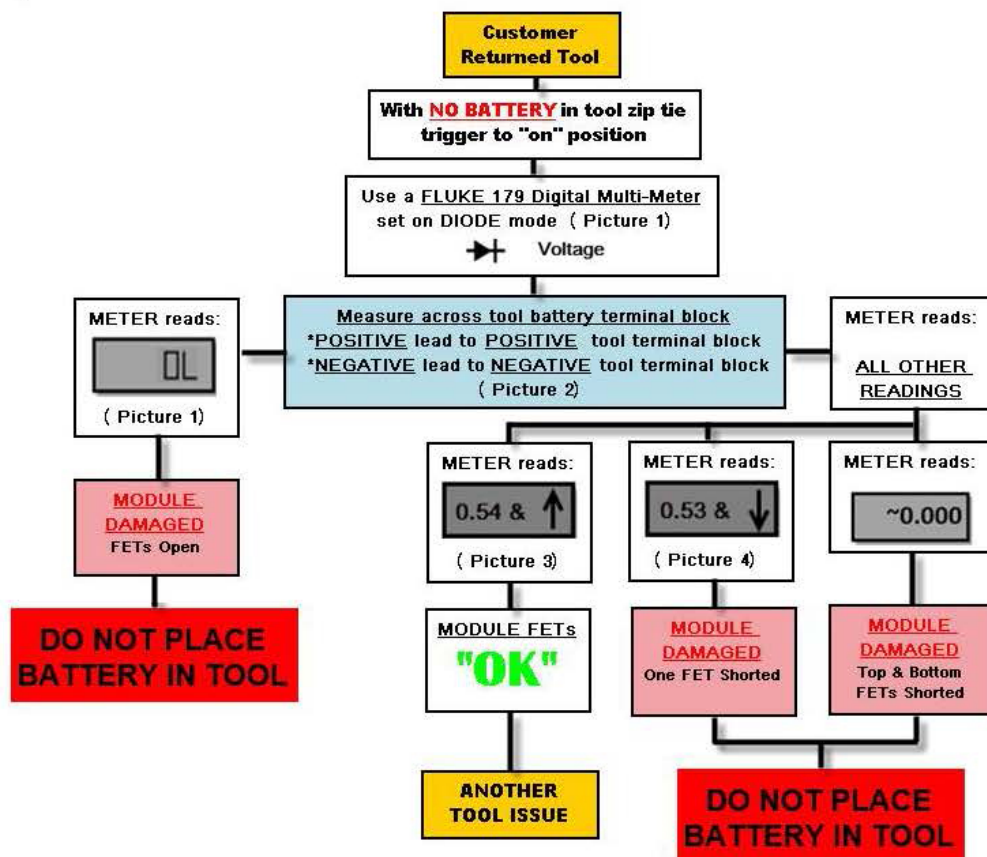
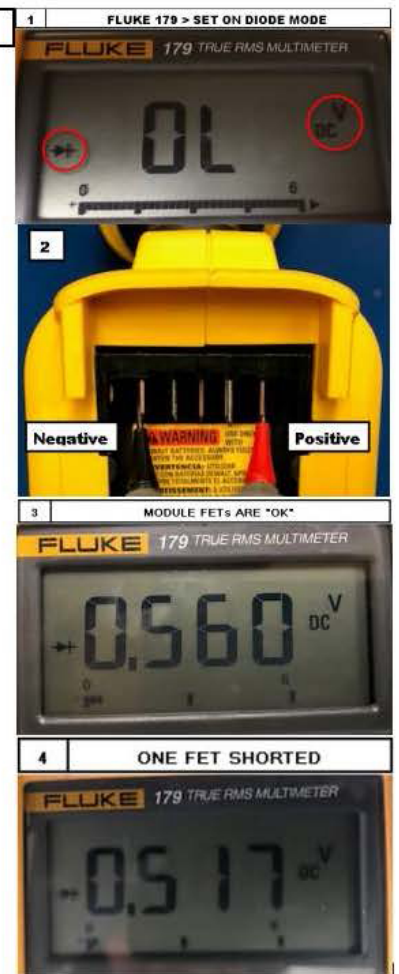
This troubleshooting guide along with a multi-meter can be used to help identify abnormal and no run tool conditions due to control module MOSFET damage. This can cause FLEXVOLT battery failure (54V mode only).

Do not connect a FLEXVOLT battery to the tool until this test has been completed if the tool is a no run.
